Analysis of False Alarms on DVOR Equipment at I Gusti Ngurah Rai International Airport

Andre Rizky Sanjaya ¹, Donna N.M. Sirait ², Muhammad Caesar ³, Akbar Erwin Lumban Gaol ⁴
Medan Aviation Polytechnic¹

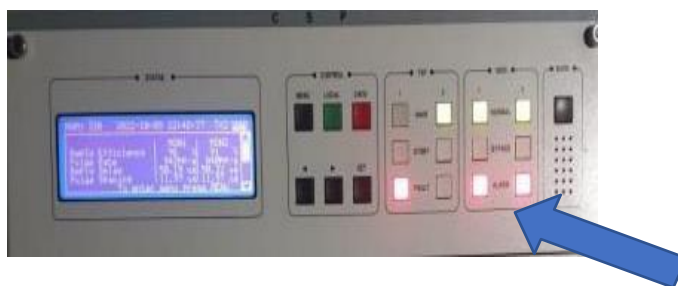
- 1) Technician Analyzes equipment that is problematic due to induction due to lightning strikes that cause *alarms* on DVOR equipment

Alarms on DVOR equipment
Source: Author's documentation, 2022

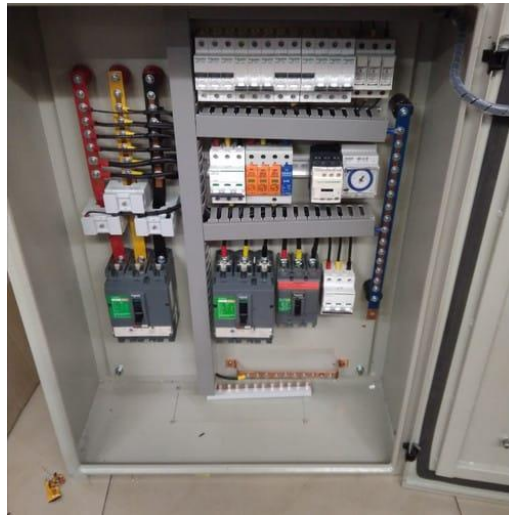
- 2) The technician checked the voltage from PLN, which is 220 VAC in the DVOR equipment panel.

Voltage check from PLN

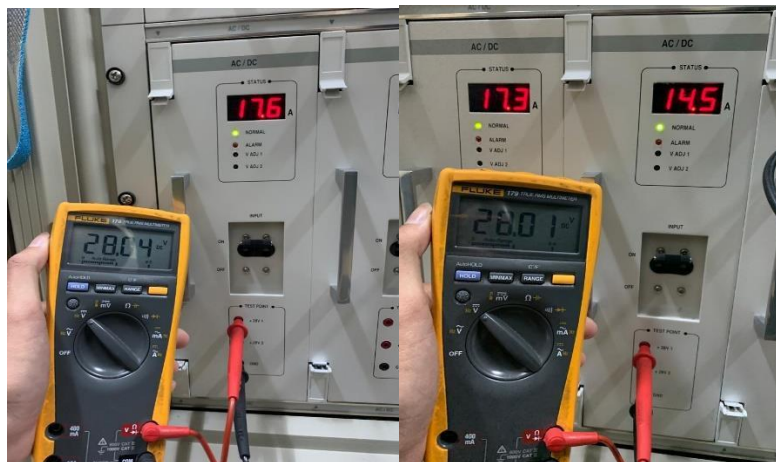
- 3) Technicians check the voltage supply on the equipment, namely on the AC/DC1 (28VDC), AC/DC2 (28VDC), DC/DC1 (+5, +7, +15, -15, 27 VDC) and DC/DC (+5, +7, +15, -15, 28 VDC) modules. After checking, it turned out that all the voltage supply on the equipment was normal.

Voltage checking on AC/DC modules
Source: Author's documentation, 2022

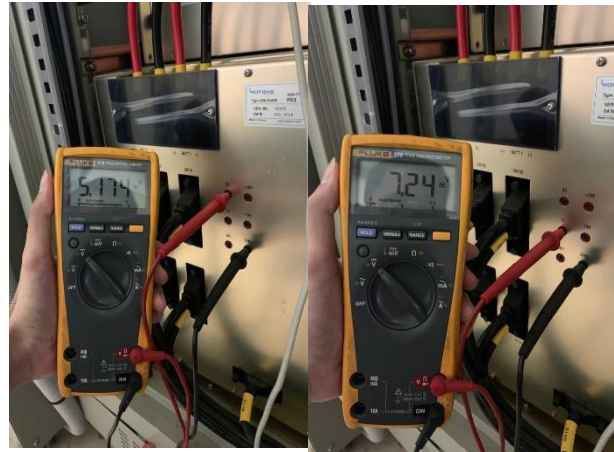
+5 and +7 VDC voltage checks in DC/DC modules

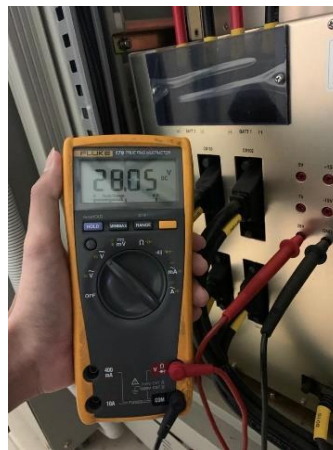
+28 VDC voltage check on DC/DC modules

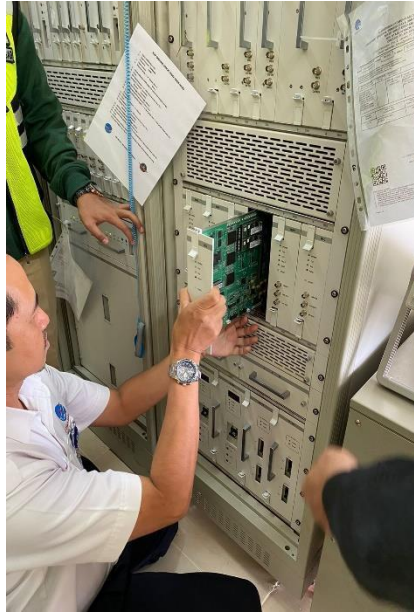
- 4) DVOR equipment cannot be controlled using LMMS. Here the technician analyzed that the DVOR equipment could not be controlled through the LMMS because there was a *failure* in the LCU module where this LCU module was directly connected as a communication *interface* with the LMMS and was the *Local Control Unit* of an equipment. Therefore, the LCU module was replaced.

LCU module replacement

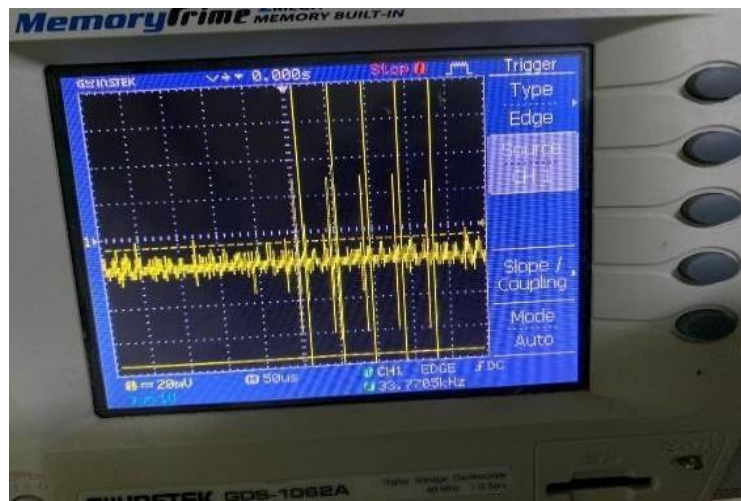
- 5) After replacing the LCU module, the technician tried to move the *transmitter* from TX2 to TX1 but could not.

The technician analyzed that *the transmitter* could not move from TX2 to TX1 due to a *failure* in the CSU module. After that, the CSU module was replaced, as a result the *changeover* could operate normally

CSU composite signal at the time of damage

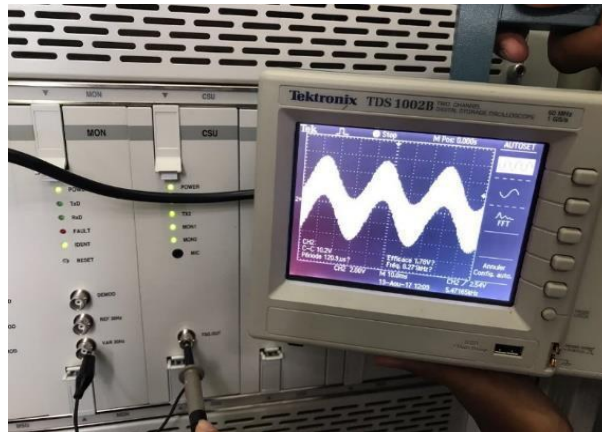
CSU Composite Signal at Normal Time

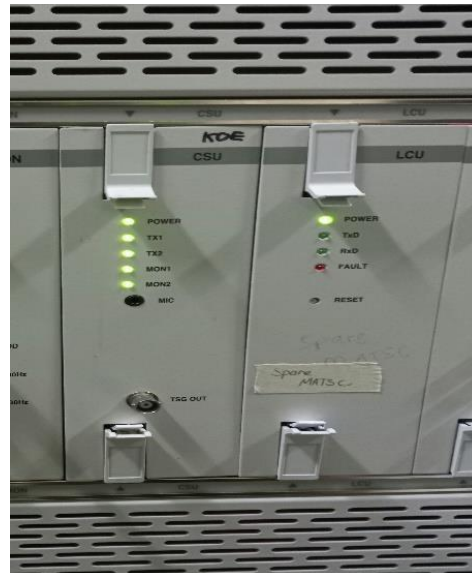
Spare CSU modules that have been installed

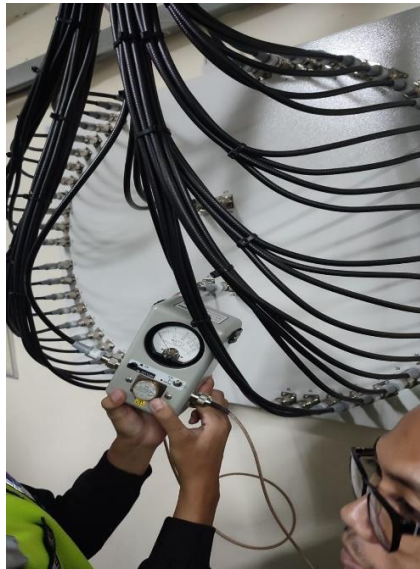
- 6) In the LMMS DVOR there is an *alarm* on the *sideband* antenna, the technician checks each *output* on the ASU module that is directly connected to the *sideband antenna* using a wattage meter. As a result, there are some antennas where the power received is greater than the power emitted. Therefore, the ASU module was replaced.

Sideband antenna check

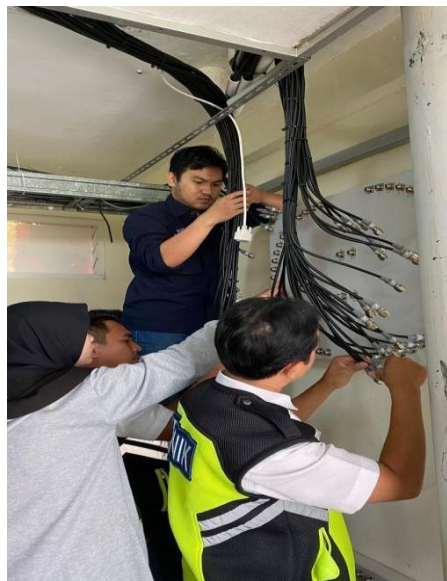
ASU module replacement Source: Author's documentation, 2022

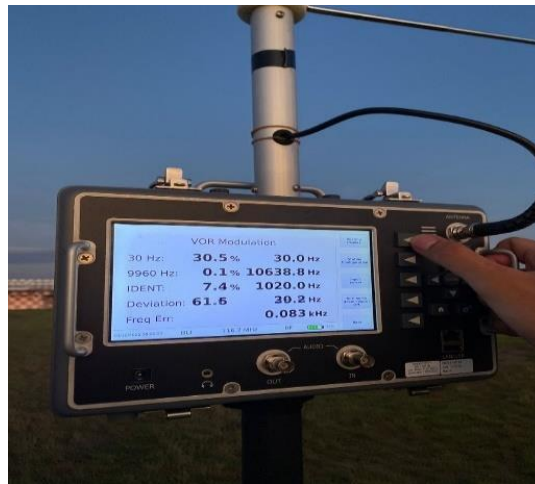
- 7) On the LMMS monitor, there is still an alarm due to *the high power carrier*. So a *ground check* was carried out, the results of the *ground check* showed that the equipment was operating normally. The technician analyzed that it was necessary to set the monitor.

Ground check DVOR
Source: Author's documentation, 2022

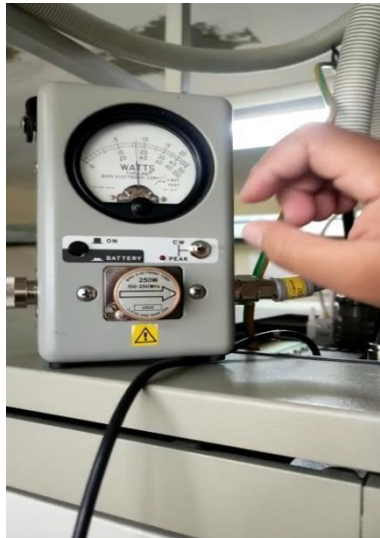
- 8) The technique of checking *the power* on the carrier antenna and the results of the check showed that *the power* on the *carrier antenna* was normal. Power carrir tolerances range from 50-100 watts, and in power cerrier equipment 85 watts.

Check antenna power using a wattmeter

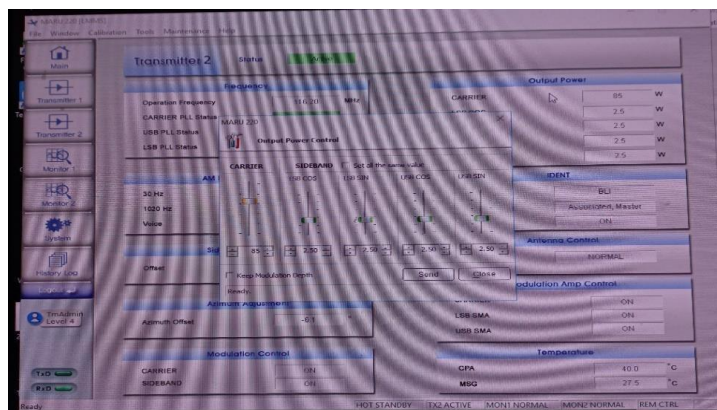
- 9) *The power on the carrier antenna after checking the results is normal, here the technician analyzes that it is necessary to set the transmitter on the LMMS*

Antenna power settings on the LMMS

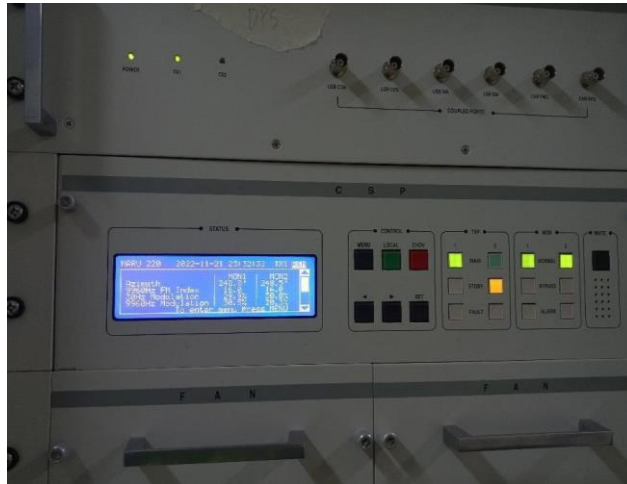
- 10) After checking *the power* and adjusting the settings on the monitor, the result was that the equipment functioned normally.

Normal display of DVOR equipment

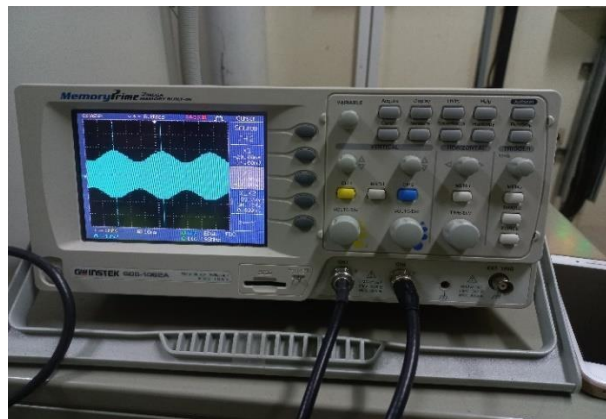
Sinyal CAR FWD

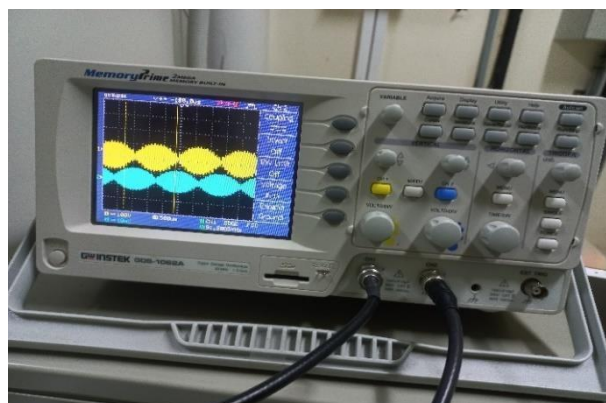
Sinyal blending function

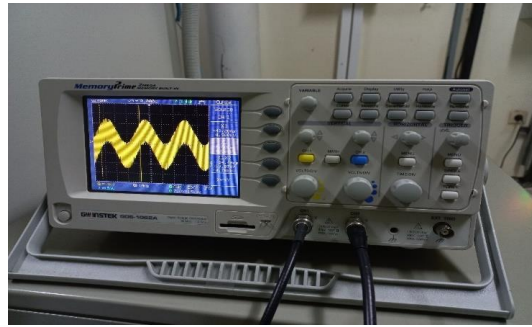
Composite signals on the CSU when the

equipment is normal
